MARYLAND INVENTORY OF HISTORIC PROPERTIES HISTORIC BRIDGE INVENTORY MARYLAND STATE HIGHWAY ADMINISTRATION MARYLAND HISTORICAL TRUST

NAME AND SHA NO.: F-2004

LOCATION Road Name and Number: Lewistown Road over Fishing Creek City/Town: Middletown X vicinity County: Frederick
Ownership: _ State X County _ Municipal _ Other
Bridge projects over: _ Road _ Railway X Water _ Land
Is bridge located within designated district?: _ yes X no NR listed district _ NR determined eligible district locally designated _ other Name of District _
BRIDGE TYPE
Timber Bridge Beam Bridge Truss-Covered Trestle Timber-and-Concrete
Stone Arch Bridge
Metal Truss Bridge
Moveable Bridge Swing Bascule Single Leaf Bascule Multiple Leaf Vertical Lift Retractile Pontoon
Metal Girder Rolled Girder Rolled Girder Concrete Encased Plate Girder Plate Girder Concrete Encased
Metal Suspension
Metal Arch
Metal Cantilever
X Concrete Concrete Arch Other Type Name 667

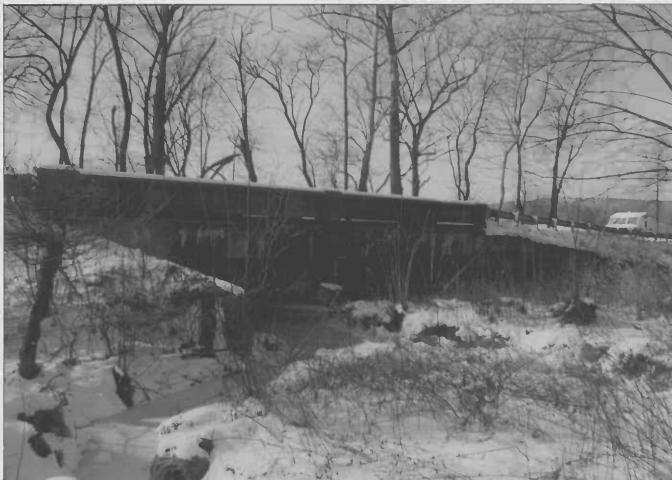
Name F2004-LEWIS TOWN RO OVER FISHING CREEK County/State FREDERICK COUNTY/MD Name of Photographer FRANK JULIAND Date
Location of Negative
Description <u>ELEVATION</u> LOOKING SOUTH
Number 20 of 35 A

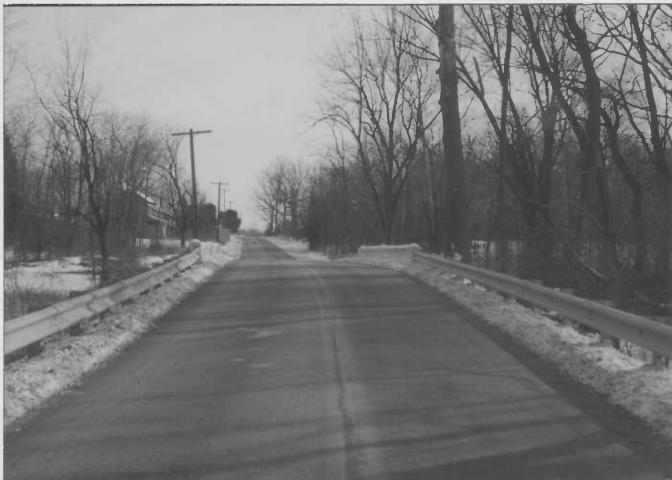
Number 21 of 354

Name F2004 - LEWISTOWN PLO UNER FISHING CAEEK
County/State EXEDERICK COUNTY/MO
Name of Photographer FRANK JULIANO
Date2195_
Location of Negative
Description _ APPRIACH EAST

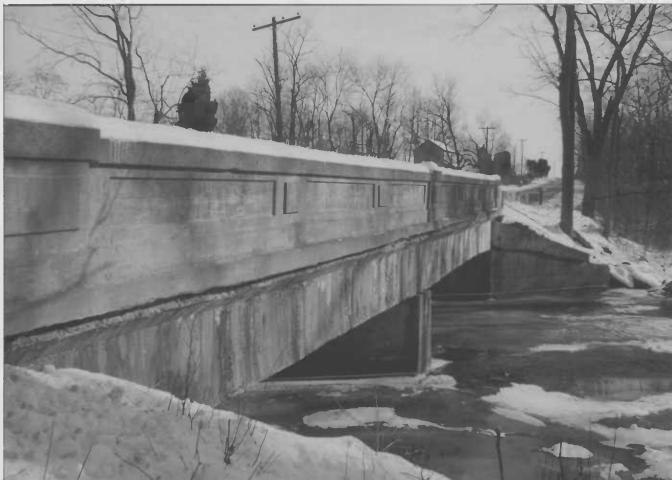
Number 22 of 35

Name F2004 - LEWISTOWN RO OVER FISHING CREEK
County/State FREDERICK COUNTY MD
Name of Photographer FRANK JULIANO
Date 295
Location of Negative _SHA
Description <u>ELEVATION</u> LODKING EAST
Description ELEVATION WORING EAST
